Manhole Inspection Summary

Manhole # S19G1_004MH

Insp Date: **4/23/08 10:45 AM**

Location Address: **2400 nieman av**

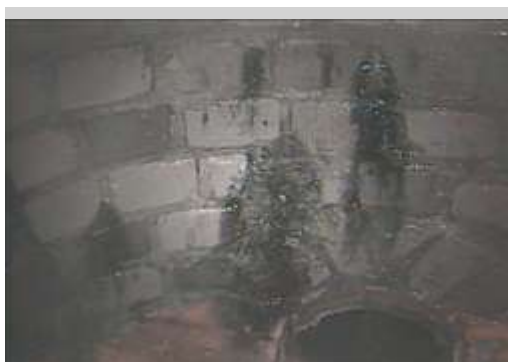
Defect 2

Infiltration: ☐ None ☐ Joint ☐ Cracks ☐ Mortar ☐ Roots ☒ **Wall**

infiltration @ barrel wall

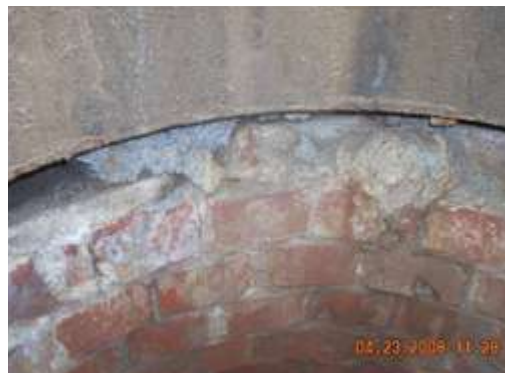
Defect 1

Condition: ☐ Sound ☐ Cracked ☐ Root Intrusion ☐ Loose Brick ☒ **Deteriorated**

deteriorated chimney

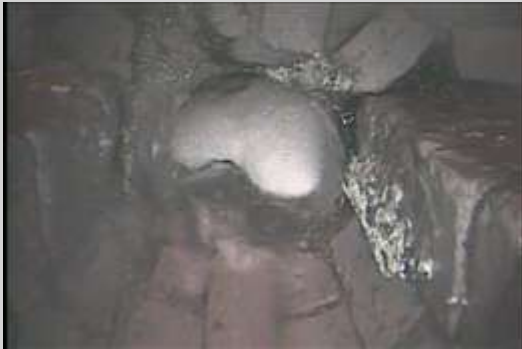
12 O'Clock Outflow

8 in. Circular Gravity Sewer
Pipe Out @ 12 O'Clock

Pipe Height: **8.4** (in.) Rod and Bar (Angled)
Pipe Material: **Clay** ☐ Pipe Lined
Invert Depth: **13.30** (ft.) Flow Characteristics: **Fast**
Deposits: ☐ None ☐ Mud ☐ Sludge ☐ Debris ☒ Grease
Silt Depth: **2** (in.) Deposits Extent: **Light**
Infiltration: **None** Pipe Seal Cond: **Unknown**

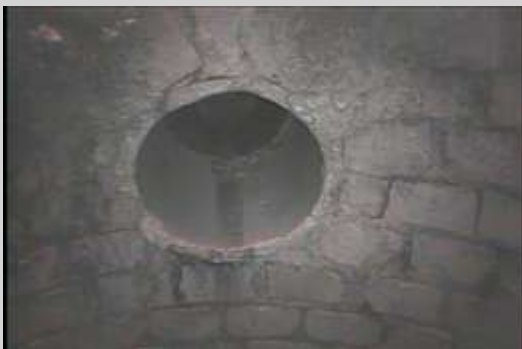
6 O'Clock Inflow

8 in. Circular Gravity Sewer
Pipe In @ 6 O'Clock

Pipe Height: **8.4** (in.) Rod and Bar (Angled)
Pipe Material: **Clay** ☐ Pipe Lined
Invert Depth: **10.21** (ft.) Flow Characteristics: **Fast**
Deposits: ☒ None ☐ Mud ☐ Sludge ☐ Debris ☐ Grease
Silt Depth: **0** (in.) Deposits Extent:
Infiltration: **None** Pipe Seal Cond: **Sound**

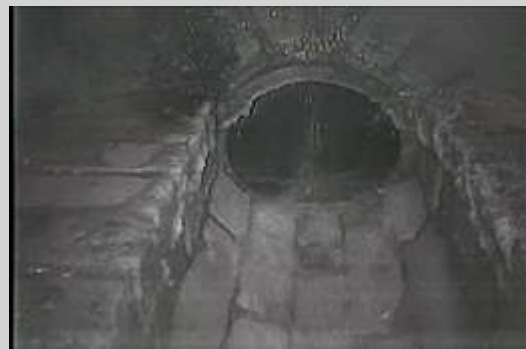
Drop In @ 6 O'Clock

Drop: **Outside** Rod and Bar
Angled: **Yes** Reading: **12.00** (ft.)
Inv Depth: **13.00** (ft.)
Drop Condition: **Open**
